Documentation Review and Advice
Groundwater Status at Closed Daylesford Landfill
16 Ajax Road, Daylesford, VIC 3460

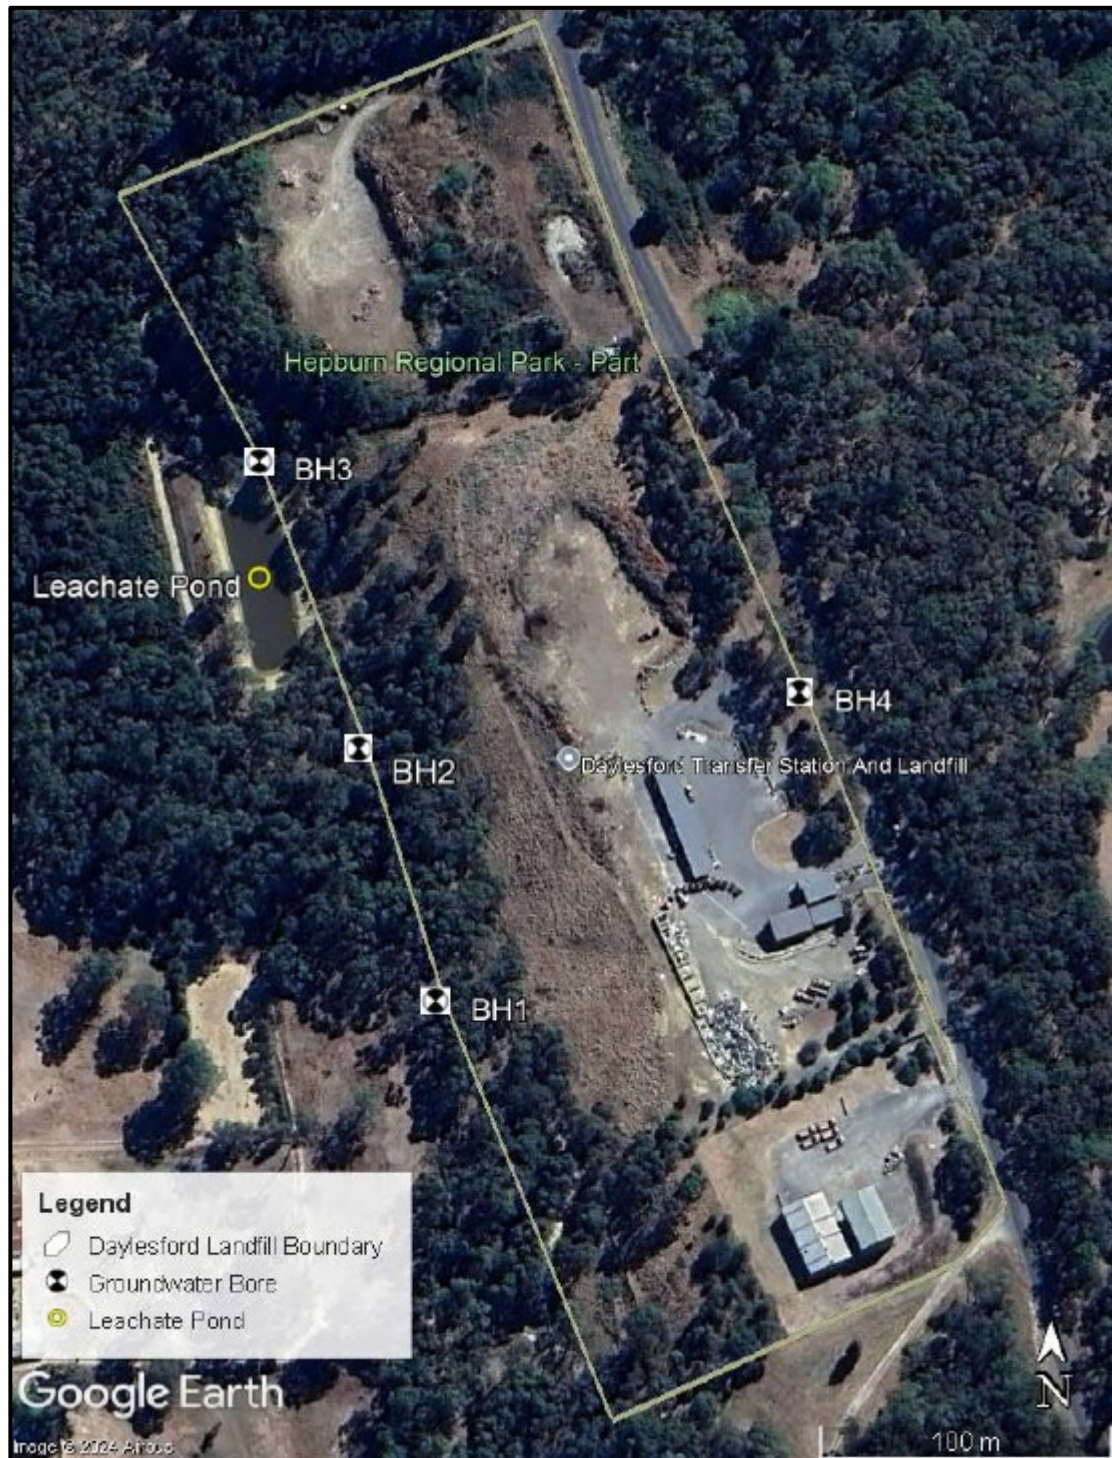
Figure 2: Groundwater Monitoring Well Locations

AEA understands that four groundwater monitoring wells (BH1 to BH4) have been installed across the site. Three of these wells are located along the western boundary, while the fourth well is positioned at the centre of the northeastern boundary, near the transfer station. Additionally, one lined leachate pond (LB1) has been installed on the site. The groundwater monitoring well locations and leachate pond are shown in Figure 2 below.

No survey data has been provided to confirm groundwater flow direction. Based on topography, the inferred groundwater flow direction is westward toward Blacksmith Gully Creek, with BH4 potentially up-hydraulic gradient and BH3 and BH2 down gradient of BH4. BH1 is likely cross-gradient. However, the lack of a confirmed flow direction introduces significant uncertainty.

The leachate pond is located in the western portion of the site; however, no monitoring wells have been installed downgradient to evaluate potential leachate impacts on groundwater in those areas. Additionally, the lack of a confirmed landfill boundary introduces uncertainty regarding the classification of BH4 as a background well. The absence of an upgradient monitoring well to the east of the landfill further complicates efforts to differentiate between naturally occurring metals and potential contamination resulting from landfill activities. BH4 consistently exhibits higher metal concentrations compared to other wells. If BH4 could be reliably classified as a background well, the elevated analyte concentrations might be attributed to naturally occurring background levels. Consequently, elevated metal concentrations in downgradient wells relative to BH4 could also be interpreted as representative of natural conditions. However, due to the limited information available and the undefined extent of landfilling activities, this interpretation cannot be substantiated. Therefore, the elevated concentrations in BH4 and the downgradient wells could equally indicate contamination associated with landfill activities.

3. Due to the lack of groundwater wells in downgradient areas, there is insufficient information to determine potential leachate impacts on the surrounding lands. It is recommended that downgradient monitoring wells be installed to evaluate any leachate impacts in these areas.
